Microabrasion Combined with Resin Infiltration to Treat a white Spot Lesion: A Clinical Case

Orlanda T*

Volume 4 Issue 10- 2020

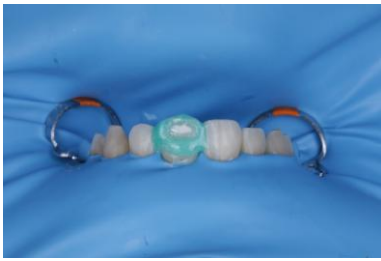
Figure 5

in order to protect the surrounding enamel during the procedure of microabrasion (Figure 5).

A rubber dam with ligatures was used in order to protect the oral soft tissues and provide a clean and dry working field. Thereafter the lesion was circumscribed with a resinous gingival barrier, the liquid rubber dam OpalDam® (Ultradent Product, Inc.) (Table 1)

The spot was therefore treated with two applications of Opalustre®, using the rubber cup at a slow RPM with medium pressure (Table 1). Each cycle was interspersed with Icon-Dry® for a visual check. Once the microabrasion was complete, it was time to switch to the Icon® procedures (Table 1). The technique requires pre-conditioning of surface with 15% hydrochloric acid, which removes approximately 40 µm of enamel surface [7, 10].

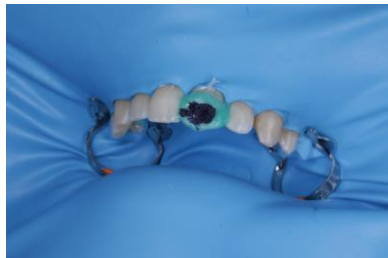
Figure 6

Then the IconInfiltrant® resin was applied (Figure 6), rubbed with a microbrush for 3 minutes in active movement, making sure that it penetrated deeply into the enamel by capillary action, filling the lesion. Care was taken to filter the surrounding light during the procedure. At the end, the resin was lightcured for 40 seconds. An immediate improvement in the esthetics was observed and a second layer of Iconinfiltrant® was applied and light cured again for 40 seconds (Figure 7).

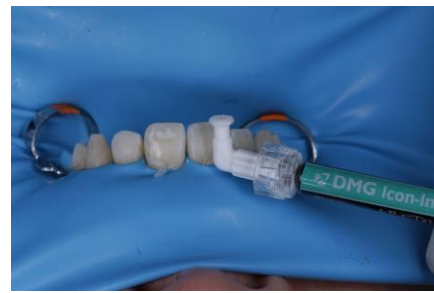
Figure 8

Under rubber dam isolation, the thickness lost during the process was recreated with the application of composite resin (Skin Ivory Inspiro, Edelweiss DR), preceded by etching the spot's edges with 35% phosphoric acid for 30 seconds (Figure 8) and the use of an adhesive bonding agent (Adhese Universal Ivoclar Vivadent). After the application of glycerin (Liquid Strip, Ivoclar Vivadent), to prevent the oxygen-inhibited layer of composite [11] on the surface area (Figure 9), the final curing process was accomplished. Post treatment photographs were taken, showing improved appearance similar to the sound enamel surrounding the site (Figure 10).

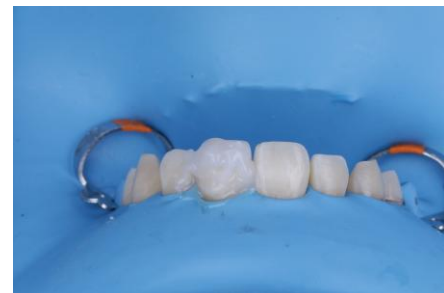
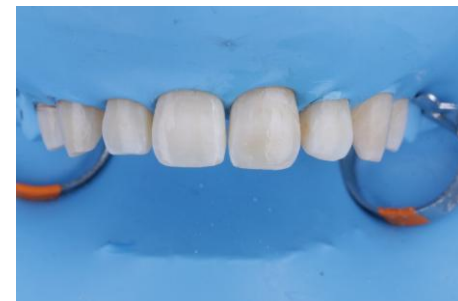
Figure 11

Finishing and polishing were performed in a second appointment (Figure 11, Figure 12) with silicone polishers for composite restorations, polishing paste and felt coated discs (Figure 13, Figure 14).
