Chronic Central Venous Catheter Erosion: A Case Report

Central venous catheter; Lung injury; Complications; Computed tomography

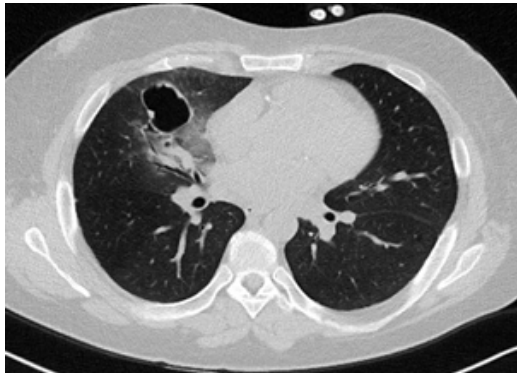
Figure 2: Axial non-enhanced computed tomography scan of the chest shows RUL cavitation with surrounding ground glass opacity.

In the ED, a chest CT scan was performed to further investigate the patient's hemoptysis, which showed a CVC traversing the SVC with an extraluminal tip at the right hilum in close proximity to the right middle lobe, where a large cavity with surrounding ground-glass opacities was observed (Figures 1 and 2). Complementary images with IV contrast in the venous phase showed partial filling of the cavity with the contrast material (Figure 3 and 4). The findings revealed a chronically eroded central line through the SVC to the right middle lobe such that it created a cavity.

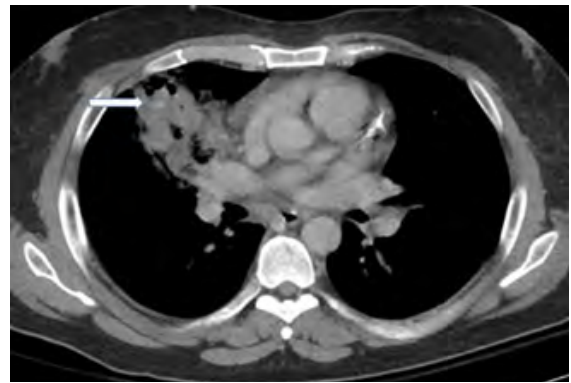
Figure 4: Axial computed tomography scan of the chest in the venous phase shows contrast pooling in the RUL cavity, proving that the central line is indeed within the RUL.

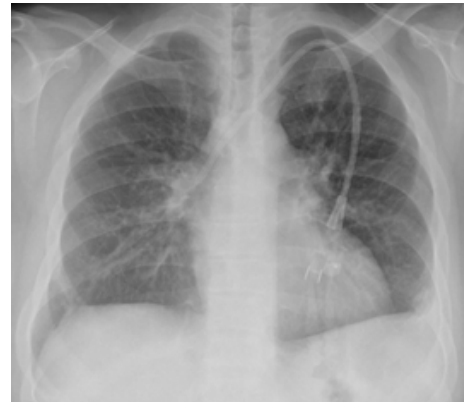
Figure 5: Frontal chest radiograph depicting the central venous catheter's tip perpendicular to the superior vena cava.

Variable acute and delayed complications can occur after the insertion of central venous catheters. One rare but serious complication that can happen is vascular erosion at the tip of the central line. The incidence of vascular erosion has been reported to be low. Knowing the ideal position of the catheter tip and the factors that may increase the risk for causing vascular erosions is essential in the evaluation of any chest radiograph following central line insertion. Several theories have been suggested to explain the mechanism that causes vascular erosions. Two major mechanisms are thought to have major effects on vascular erosions; the first is mechanical irritation from the catheter tip to the vessel wall. The other is chemical irritation of the intimal layer of the vascular wall by hyperosmolar solutions. In our case, abutment of the catheter tip was inserted in the superior vena cava at an angle of 45° perpendicular to the vessel wall, as shown on the post-procedure chest radiograph (Figure 5).
