Research Article

An Evaluation of Overhanging Dental Restorations' Frequency and Localization in a Group of Yemeni People in Sana'a City – Yemen

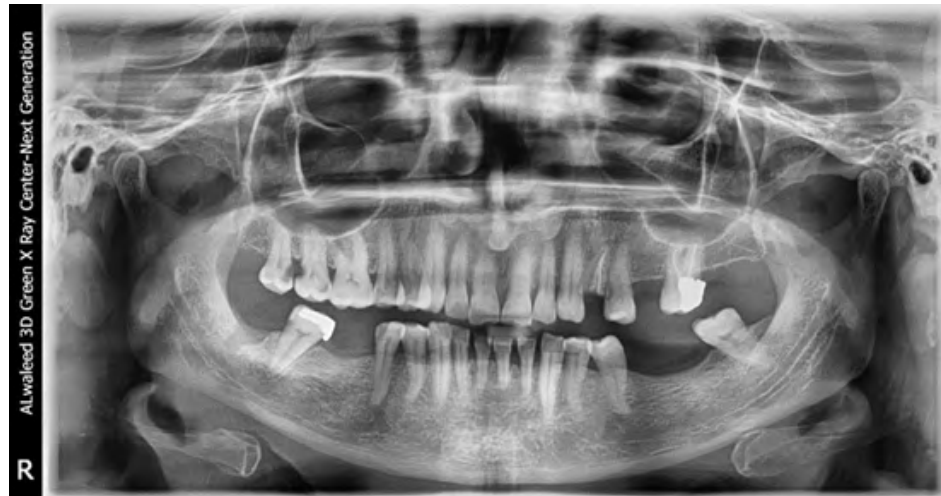
Figure 1: Panoramic images of overhanging maxillary left second molar and mandibular right second molar

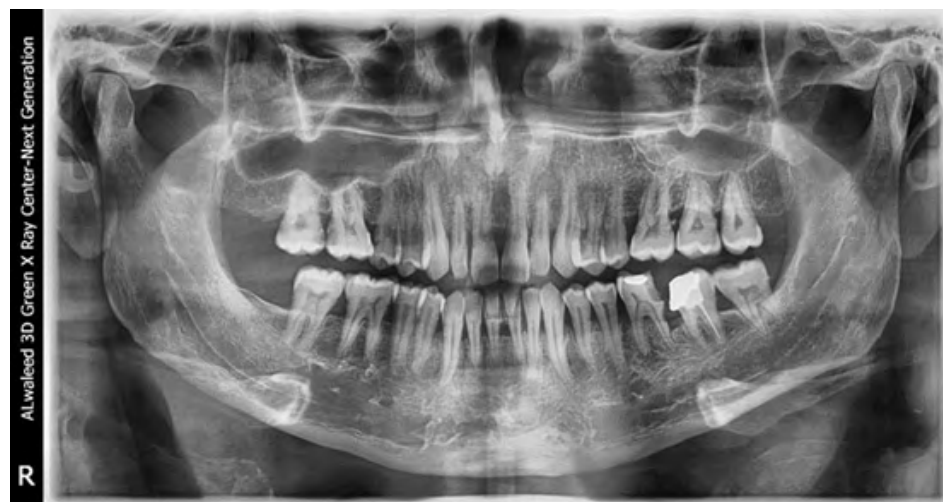
Figure 2: Panoramic images of the overhanging mandibular left second molar
